What's Growing On in the Field—Spring 2007--by Jason Lopez, Resources and Trails Manager

Although we prefer the rain, one benefit of an underachieving Old Man Winter is that our trail maintenance responsibilities were a little less intense this year. Which was very convenient because what was growing on in the field was trail construction. Two projects, Bernardo Mountain Trail and Del Dios Gorge Trail, dominated the time and effort of field staff and Dust Devil volunteers Rich Weir and Jerry Rockwell.

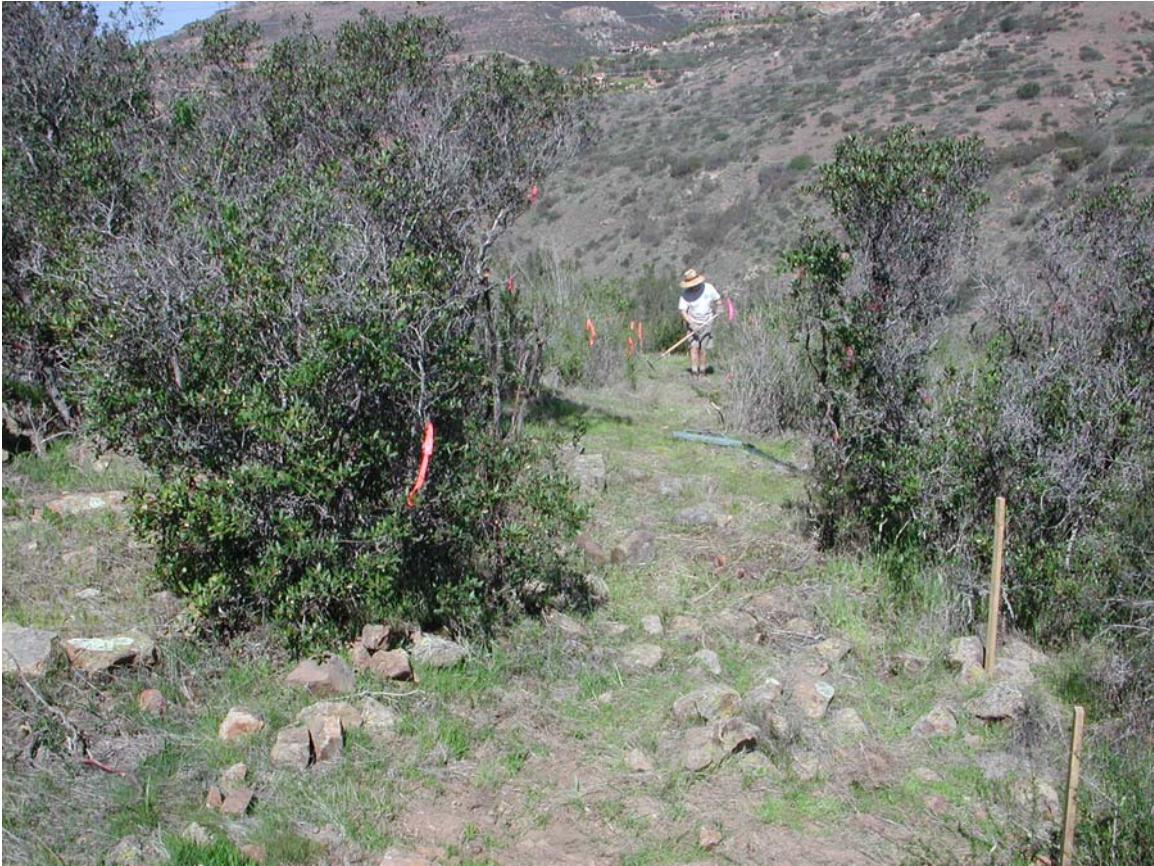
Del Dios Gorge Trail during the “clearing and grubbing” stage of construction.

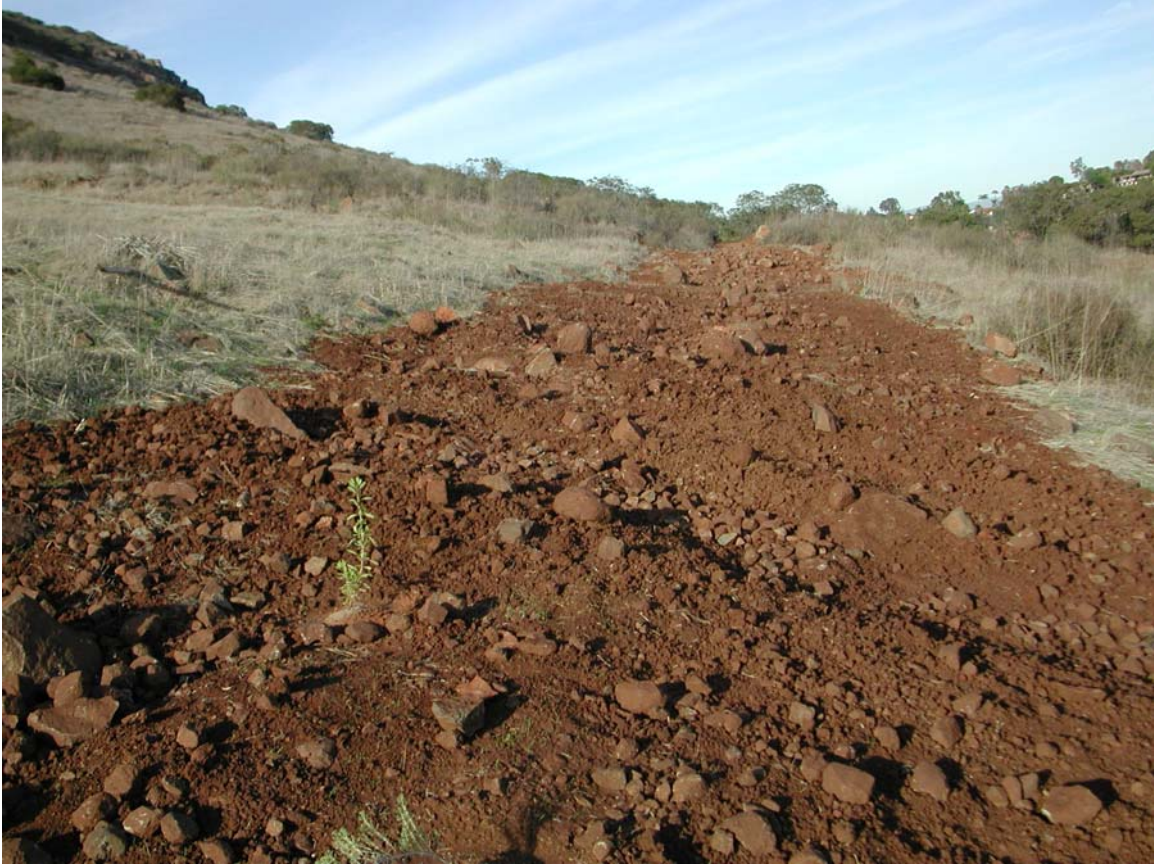
Obliterated section of trail/road on Bernardo Mountain – Soil was recovered from the downhill side of the old road cut and returned to the roadbed then planted with native species. Rocks were redistributed in order to shade soil and plants and provide habitat for reptiles and insects.

West of where the Lake Hodges North Shore Trail crosses Felicita Creek, the BMST paralleled the North Shore Trail for approximately ¼ mile and both trails had severe erosion issues. The general area contains sensitive species such as California gnatcatcher and cactus wren. Many shortcut trails existed between the BMT and the North Shore Trail that cut through sensitive habitat. Over the years, Park Rangers attempted to control the shortcutting by installing signs and barriers but having the trail in clear sight must have been too tempting because it became evident that the problem would require more effort and resources. The Park created a better connection between the two trails and restored the old trail, therefore increasing the amount of continuous sensitive habitat, alleviating the need for extensive and expensive fencing, and providing enhanced access for recreation.

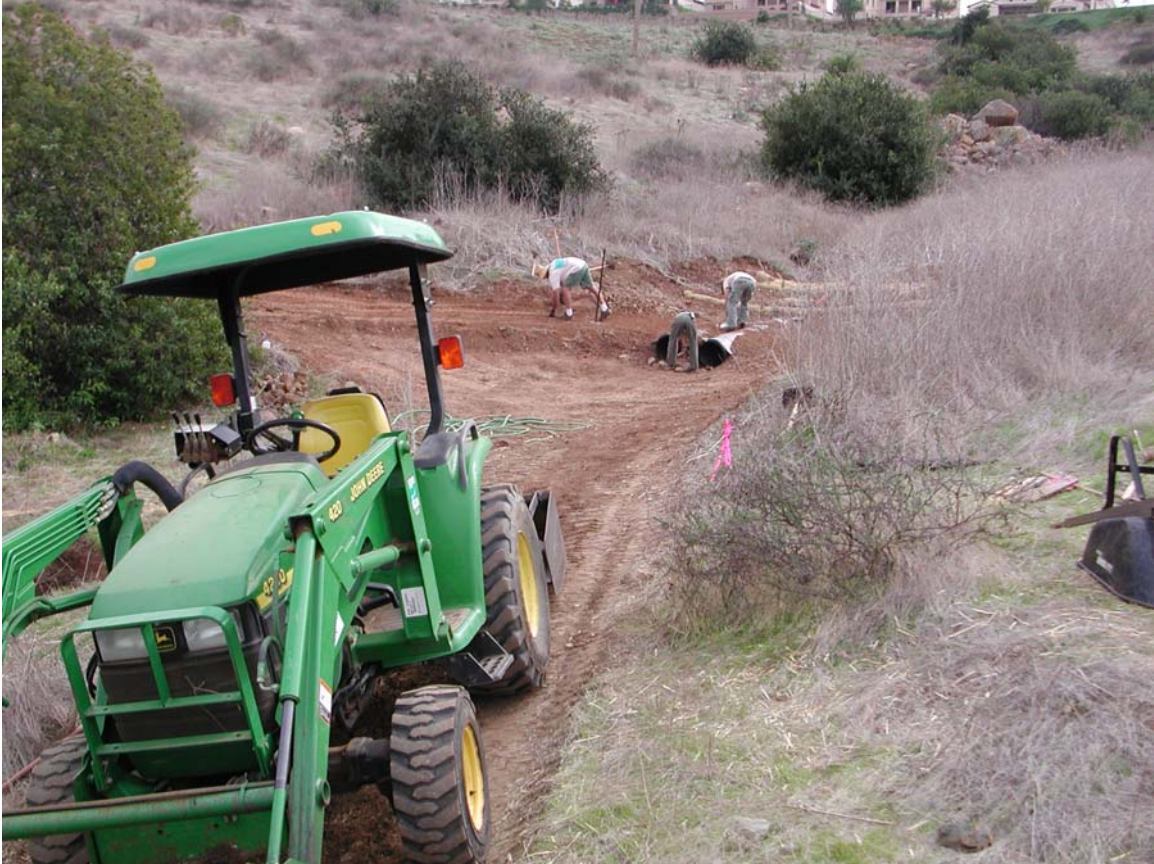
Park Rangers work diligently to finish the crossing before it rains. This drainage contains heavy water flows and much effort was made to create a sustainable crossing. Culverts were installed along with erosion control mechanisms and native plants. The plentiful rock that was excavated during trail construction was used to create check dams to slow the flow of water. The work was tested by a decent winter storm and faired well.

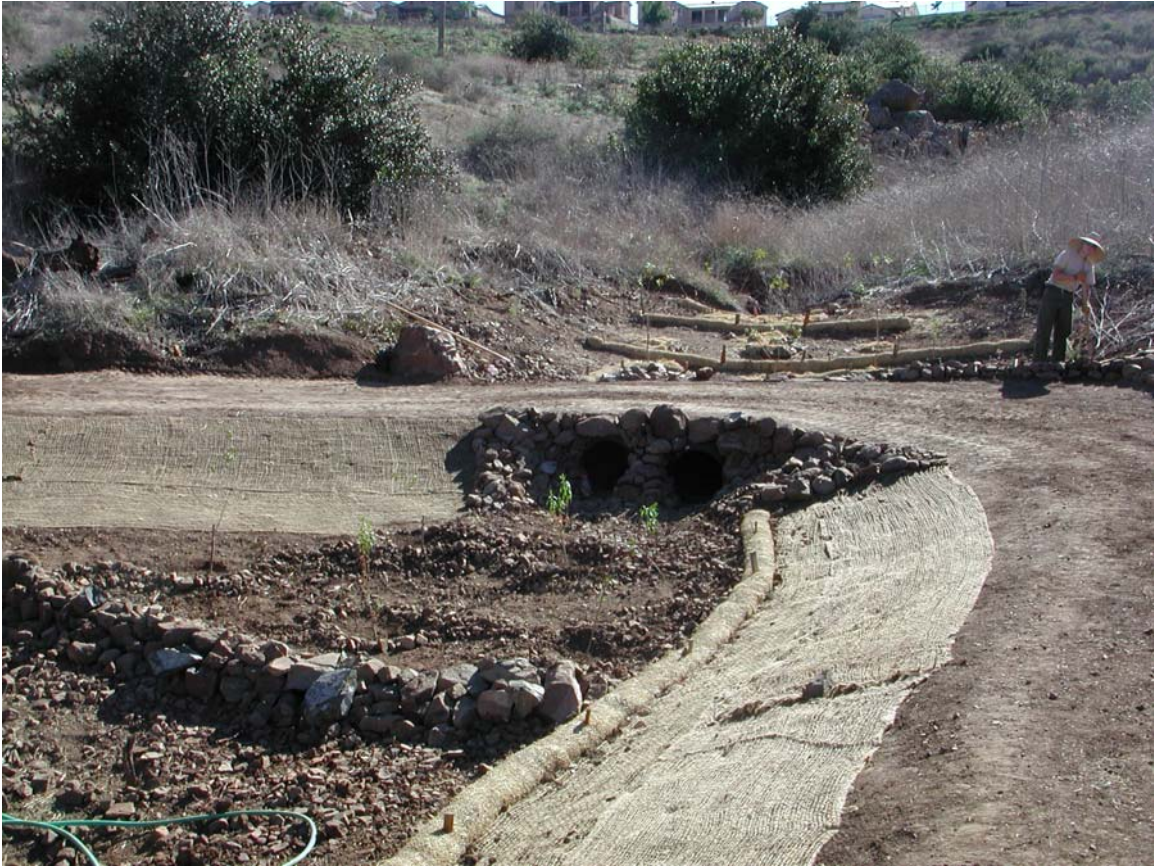
Mule Fat (*Baccharis salicifolia*) was densely planted near the trail and will be nurtured through the summer months. These plants will help to control erosion next rainy season and will eventually develop a dense matting of roots that are a essential component of permanently stabilize the crossing. Additional planting will also occur as needed. The site will be carefully monitored and maintained until the area is deemed stable. In the past, ranchers piled huge boulders into the eroded drain.

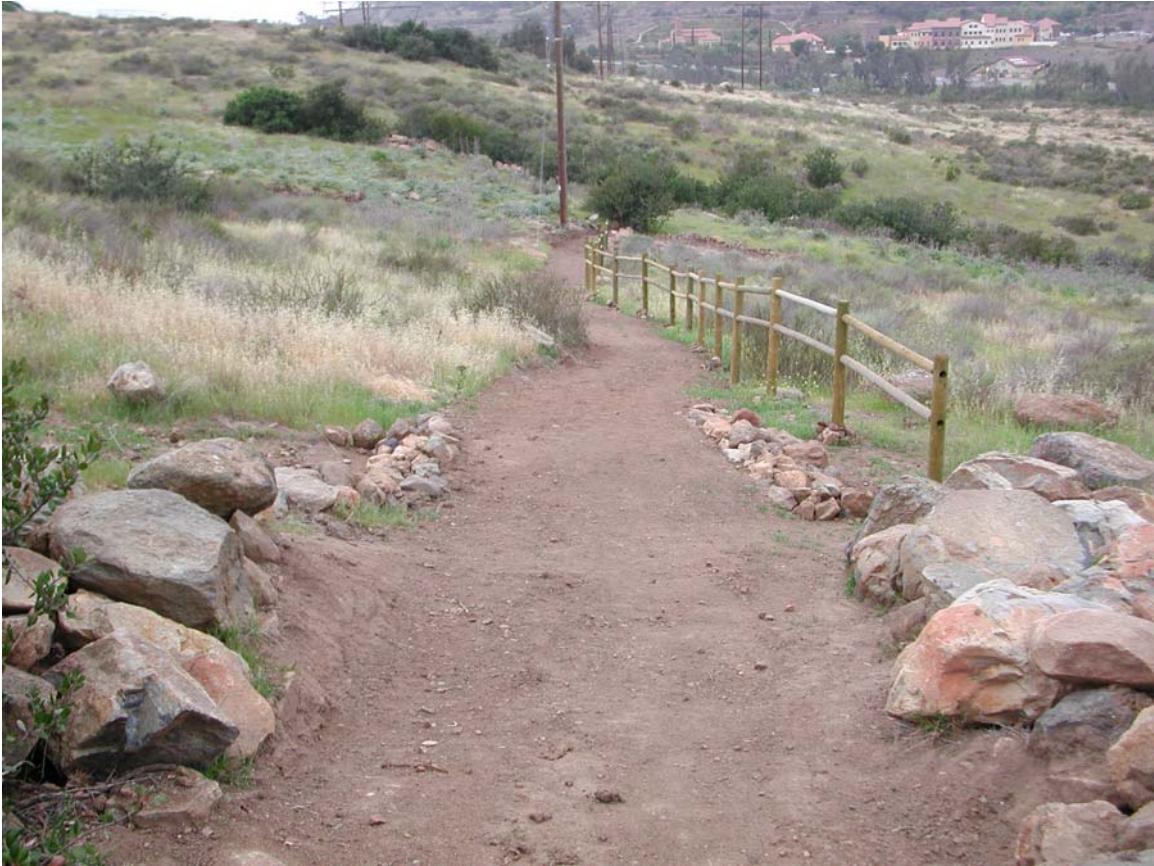
This seamless transition from SDGE road to trail is the result of a great deal of effort. Large rocks had been piled up along the road and were moved in order to get the trail through. In addition, several water drainage issues were resolved. The rocks lining the trail near the lodge pole fence are actually a drainage mechanism called drainage lenses where the dirt trail rest on a bed of rock covered by a fabric therefore allowing water to drain or seep under the trail.
