## Rebuilding the Sikes Adobe Farmhouse

The story of the second restoration and

reconstruction of the Sikes Adobe farmhouse became a reality on August 24, 2009, when ground was broken for rebuilding after the Witch Creek fire.

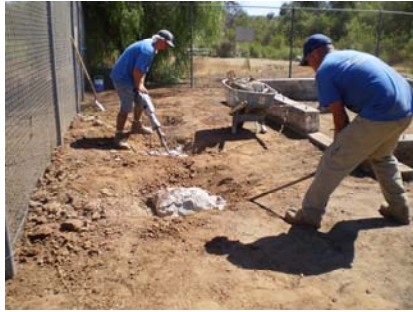
The first steps involved removal of the existing concrete footings which had supported the east and west porches, and the wraparound porch on the south end of the building. Attention was also given almost immediately to the remains of the adobe walls, which had withstood the winter of 2007-2008, due to stabilization measures installed by the River Park and the corrugated material which directed rainfall away from the tops and sides of the adobe.

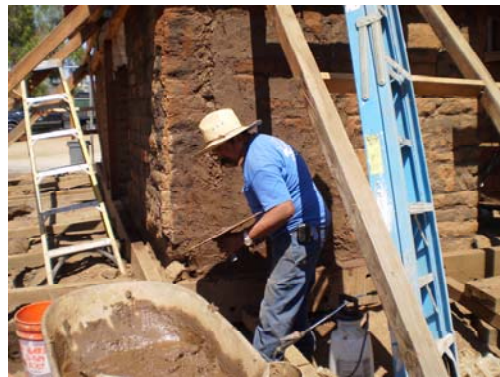
The making of adobe for the purposes of filling and patching cracks took place at the work site, with local material and some imported material.

The west wall had fared the worst as a result of the fire and subsequent rainy seasons, and it will therefore receive the greatest number of new bricks.

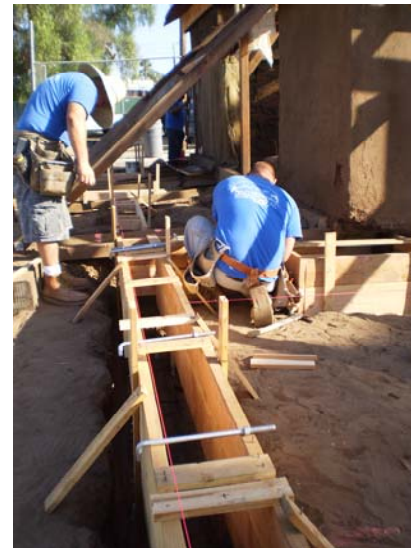
October saw more activity in the preparation of the foundations for the new porches and for the Sitting Room. Areas from which existing concrete had been removed required some filling before the new wooden forms could be constructed and ready to receive the new concrete.

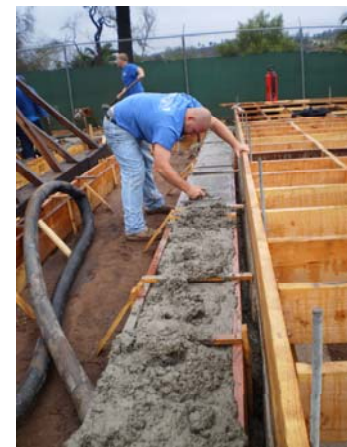
Forms were built on both the east and west sides of the adobe, in areas which correspond to the porches on those sides, in the area of the Sitting Room, and around the south side, where the bedrooms and hallway will be reconstructed.

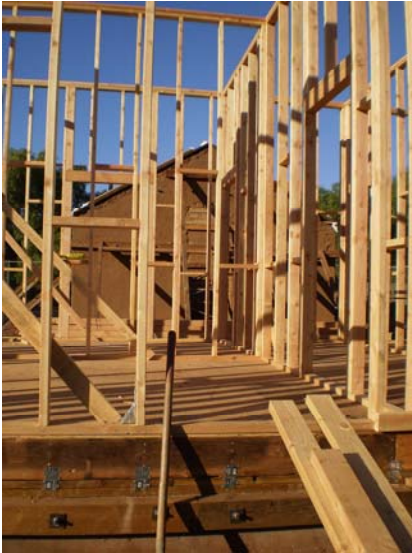
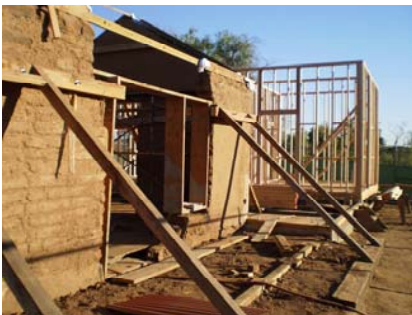
Once the new concrete was in, framing of the south end of the building began and progressed very rapidly!

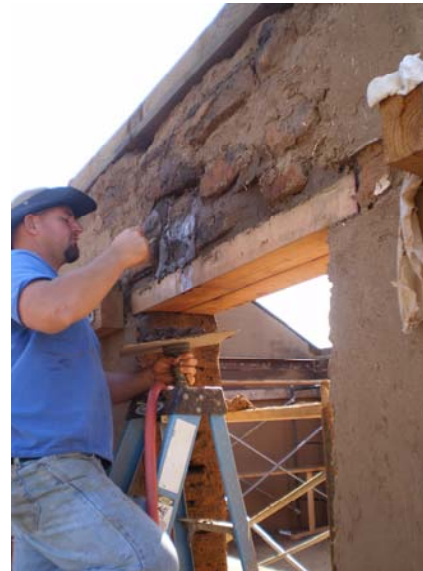
At the same time as the south end began to take shape, work on the adobe walls and their surfaces continued. Headers for the doorways and windows were put into place, with additional adobe and partial bricks as needed to replace failing sections.

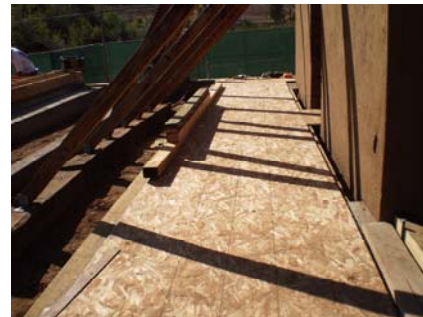
With the south portion of the building framed, work on the Sitting Room began, in the shape of framing for its roof and walls.
